TURBOJET-ENGINE EVALUATION OF AISI 321 AND AISI 347

STAINLESS STEELS AS NOZZLE-BLADE MATERIALS

By Floyd B. Garrett and Charles Yaker

NACA RM E9K17

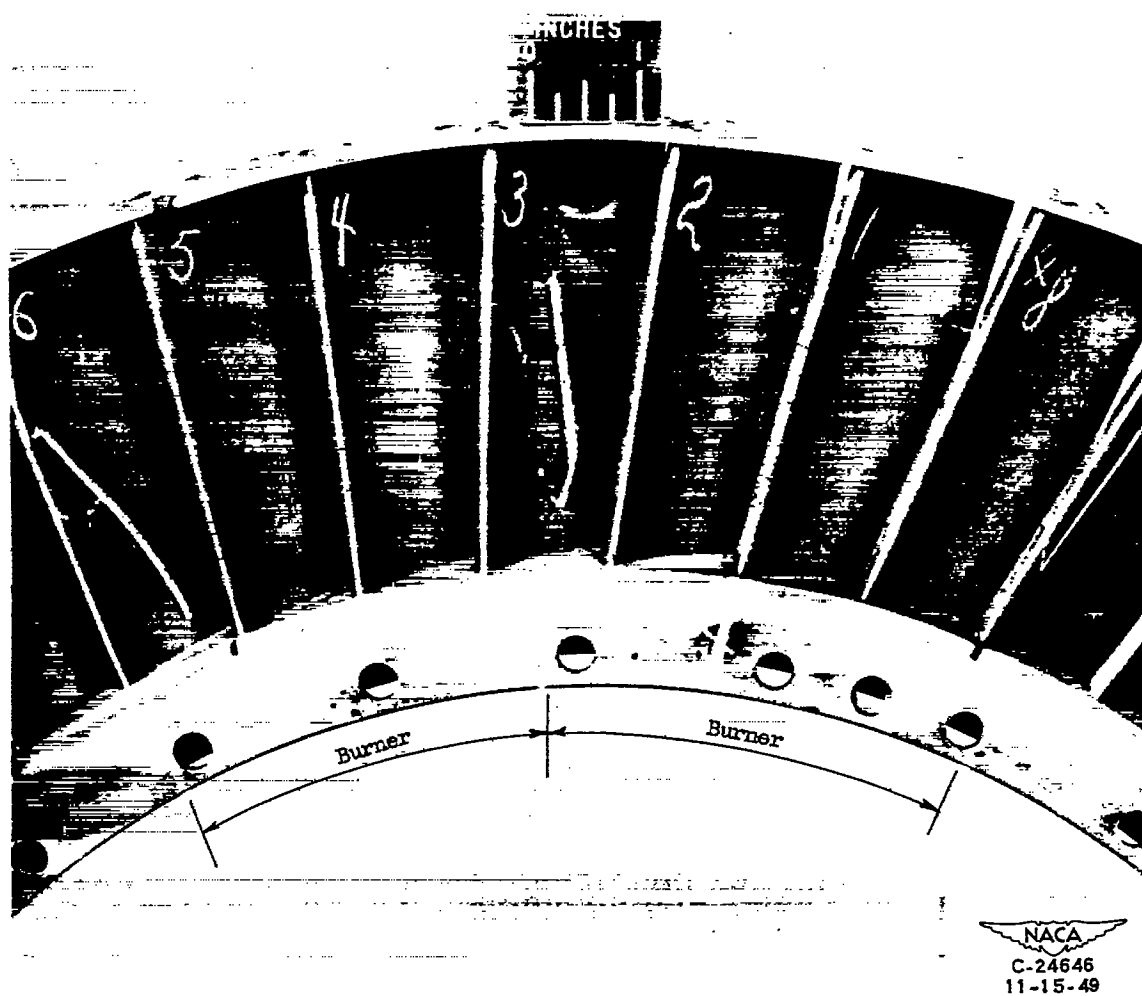
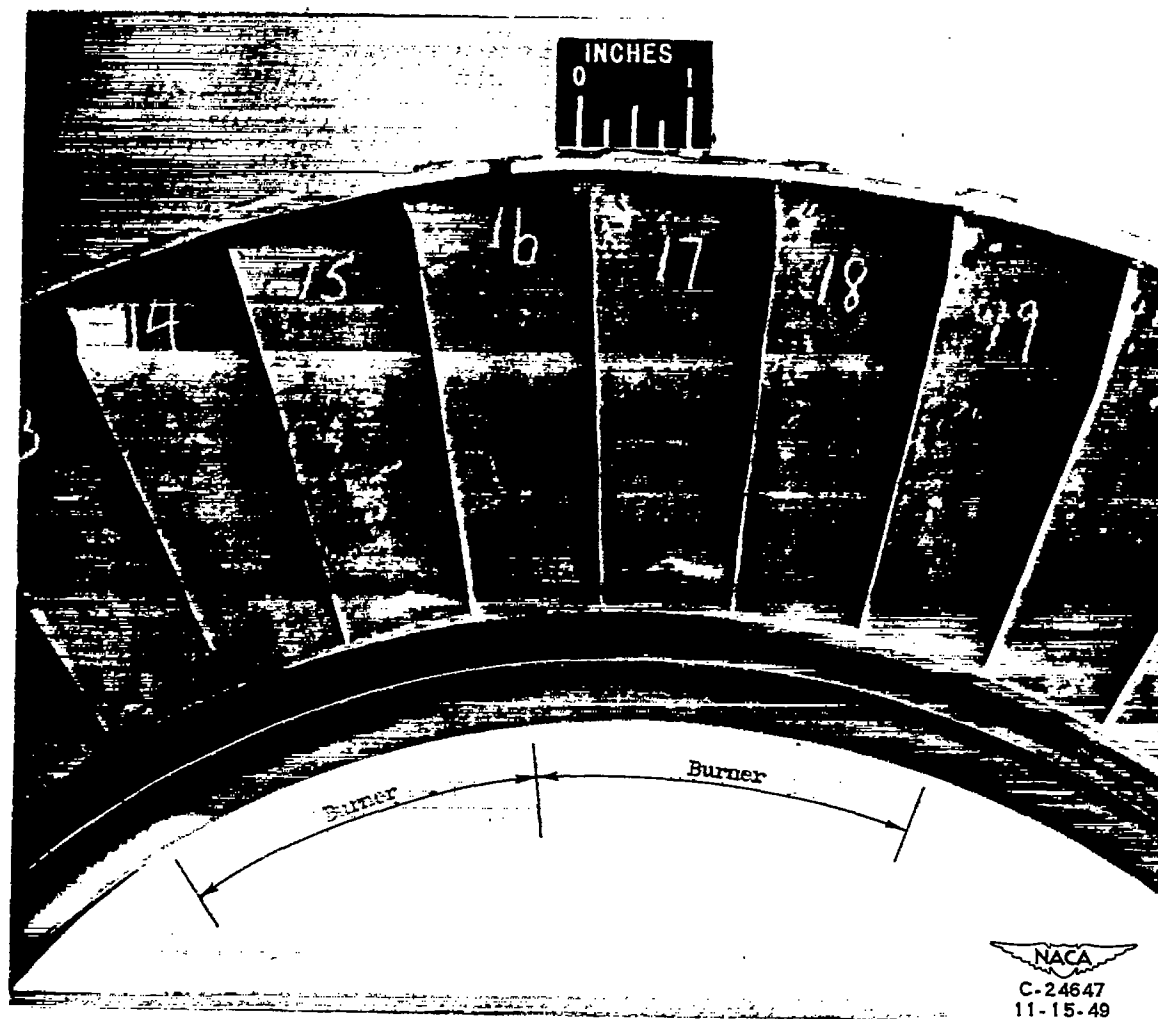
Examination of the nozzle diaphragms after operation revealed that a definite relation exists between burner location and blade cracks. Typical examples of the condition of the diaphragm blades after 319 cycles (106 hr, 20 min) of operation are shown in figure 2. These photographs clearly indicate that the severely cracked blades are generally located opposite the center of the burner outlet. Slight differences were noted between blades opposite various burners, which can be attributed to differences in combustion characteristics of the burners.

Figure 2. - Portion of nozzle diaphragm 3 after 319 cycles (106 hr, 20 min) showing blade condition with respect to burner locations.

Figure 2. - Concluded. Portion of nozzle diaphragm 3 after 319 cycles (106 hr, 20 min) showing blade condition with respect to burner locations.

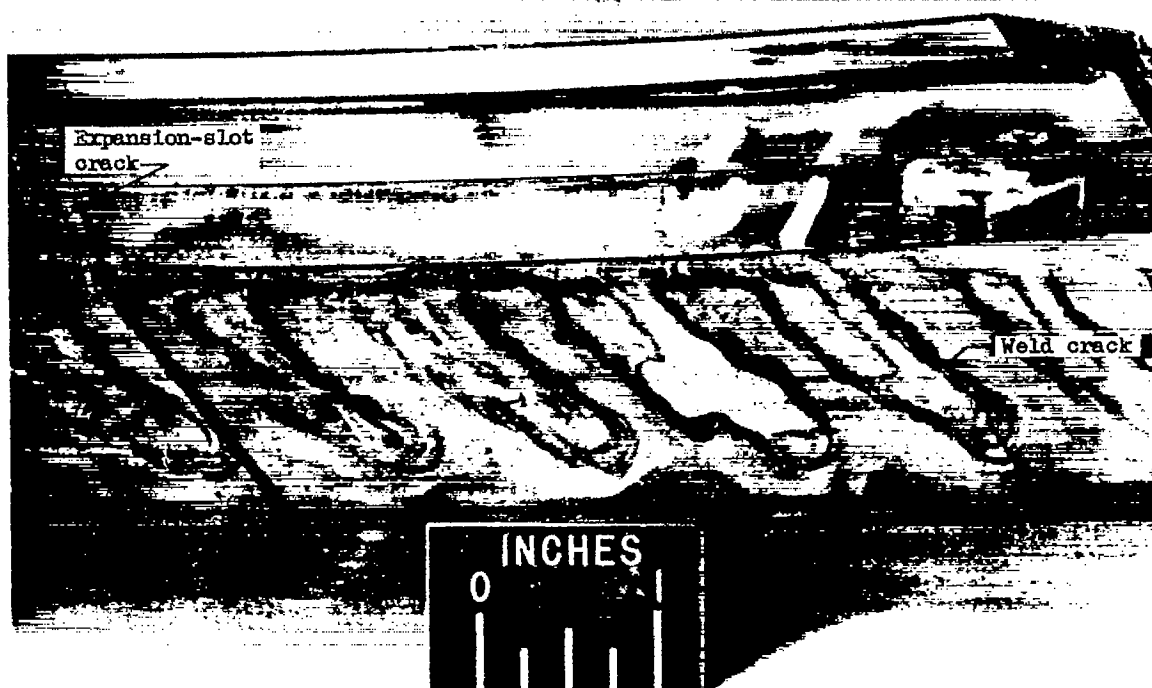
One of the more severe weld cracks is shown in figure 4. The location of the crack is typical of both types of weld. Shown also is a crack in the spacer ring at the end of the expansion slot. Cracks of this type were found at the end of all the expansion slots in the inner-spacer ring of nozzle diaphragm 3. Similar cracks were present in nozzle diaphragm 1 but not in nozzle diaphragm 2.

Failure of welds and inner-spacer ring. - The weld and inner-spacer-ring-slot cracks were probably caused by stresses resulting from unequal thermal expansion between blades due to differences in temperature between burner centers and edges and also differences in temperature from burner to burner. These conditions can possibly be eliminated by changes in design.

Figure 4. - Typical inner-spacer ring and weld cracks in nozzle diaphragm 3 after 319 cycles (106 hr, 20 min) of operation.

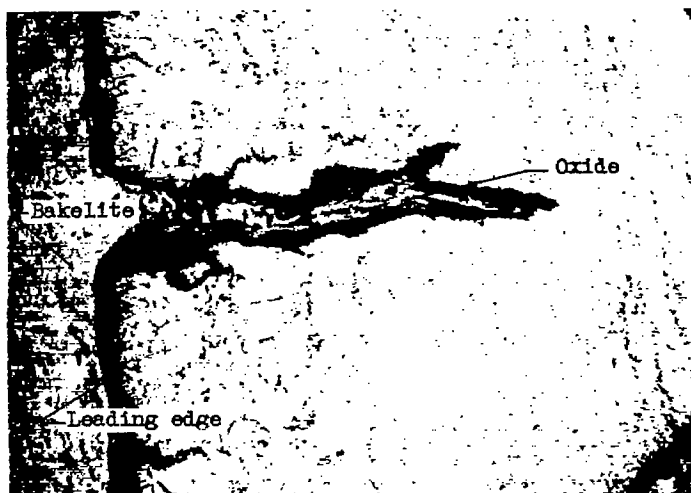
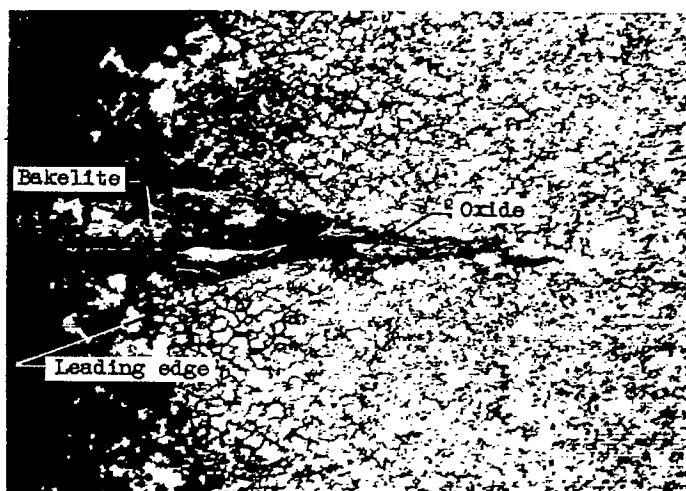
The structures of the two types of alloy before operation are shown in figure 5. Each structure consisted of small equiaxed grains of austenite containing small patches of complex carbides. Typical leading-edge cracks in the two alloys after 319 cycles (106 hr, 20 min) are shown in figure 6. This figure indicates that some intergranular penetration and precipitation have occurred at the leading edge of the AISI 347 blade. The AISI 321 blade shows no appreciable intergranular penetration. Each of the cracks shown is about 1/32 inch long. In the case of both blades, there were much longer cracks; and in the case of AISI 347 blades, the cracks

Leading edge. - Microexamination indicated that the leading-edge cracks of the two alloys (fig. 6) were different in nature. The AISI 347 blade cracks were similar to an intergranular creep type of failure and the AISI 321 blade cracks similar to corrosion-fatigue failure. The AISI 321 blades also revealed some intergranular cracks (fig. 9). In both cases, however, the number of cracks and their respective depths were of the same magnitude. The exact mechanism of cracking cannot be determined, but these failures can be regarded as resulting from the combined effects of constant thermal stress, alternating sudden thermal stress, and the oxidizing atmosphere.

Figure 6. - Typical leading-edge cracks after 319 cycles (106 hr, 20 min) of operation.  
X100.

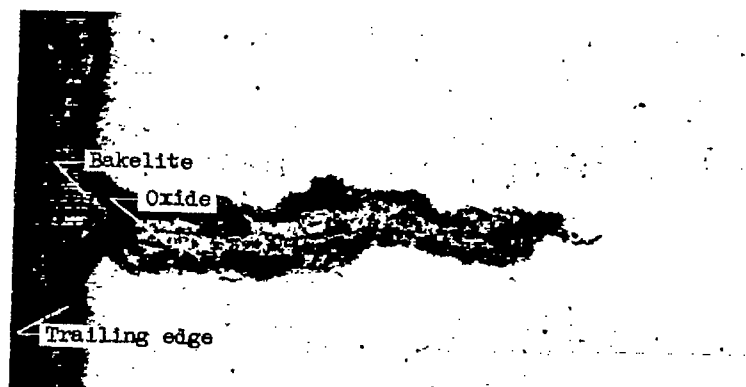
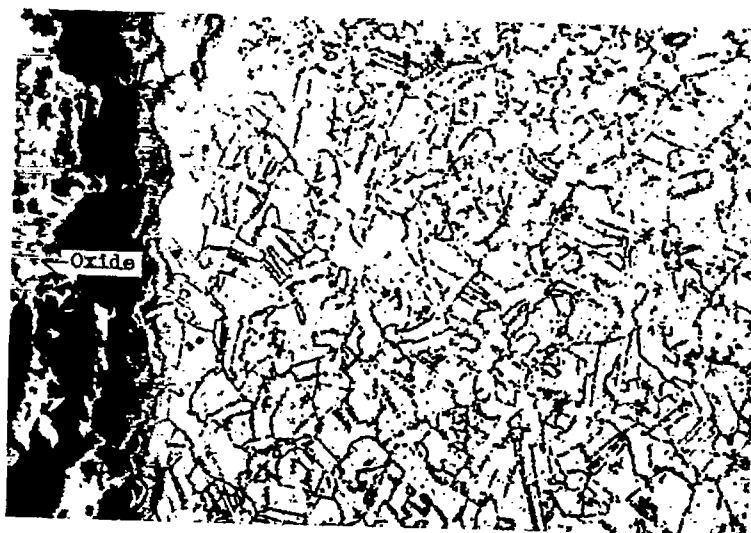
extended far beyond the area of intergranular penetration. A typical trailing-edge crack is shown in figure 7. This crack is representative of trailing-edge cracks in both types of alloy. In neither alloy did appreciable intergranular penetration of the trailing edge occur. The alloy structure along the crack (fig. 7(b)) shows evidence of a heavy intergranular precipitate. This precipitate was visible in the trailing edges of both types of blade and in the leading edge of the AISI 347 blades. Inasmuch as some blades were warped at the trailing edge, the edges were evidently highly stressed. The presence of large stresses probably increased the rate of precipitation in the grain boundaries near the trailing edge.

Trailing edge. - The cracks in the trailing edges are different from those in the leading edges. Instead of exhibiting a large number of cracks, as evidenced in the leading edge, there were only a few large cracks. Microexamination indicated a crack propagation similar to that produced by corrosion fatigue. Evidence of intergranular cracking, however, was also present. Because many of the blades had warped trailing edges, it is apparent that the thermal stresses were higher in the trailing edge than in the leading edge. This increase is due to the thinness of the trailing edge. These cracks may therefore result from stress only. Once cracks started, successive cycles resulted in deeper cracking, relieving the stress and leaving the rest of the edge crack free.

Figure 7. - Typical trailing-edge crack of AISI 347 stainless steel after 319 cycles (106 hr, 20 min) of operation.

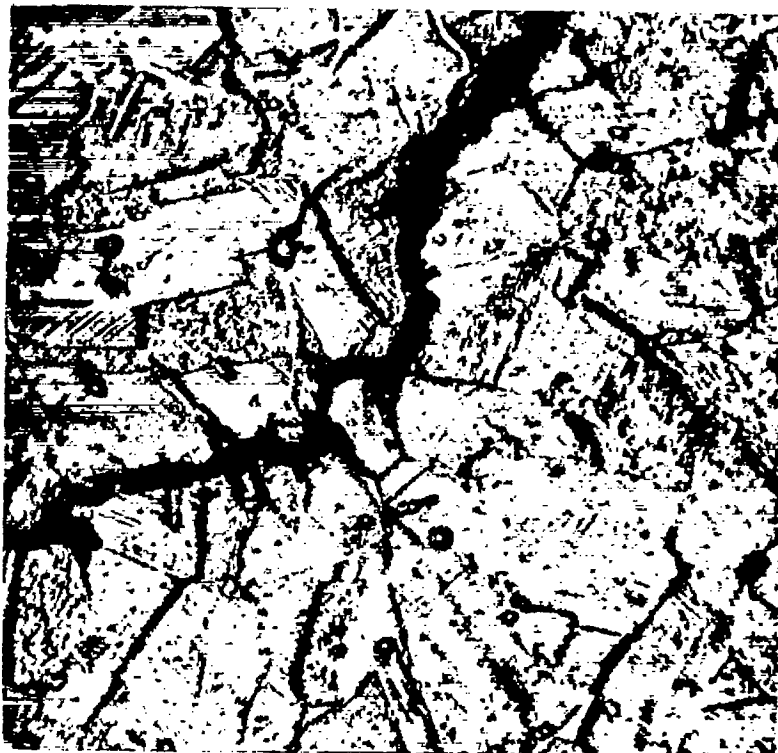
Examination of the cracked AISI 347 blade in nozzle diaphragm 2 indicated that the cracks in both the leading and trailing edges were intergranular. These cracks contained little or no oxide, inasmuch as they occurred between 70 (23 hr, 20 min) and 80 cycles (26 hr, 46 min) of operation with no further operation. The intergranular penetration at the tip of a crack, which is typical of cracks in both edges, is shown in figure 8. Two types of penetration beginning at the leading edge of a blade are indicated in figure 9. One type is intergranular penetration, and the other is surface pitting.

Figure 8. - Intergranular crack propagation in AISI 347 stainless steel after 80 cycles (26 hr, 40 min) of operation. Oblique illumination; X1000.

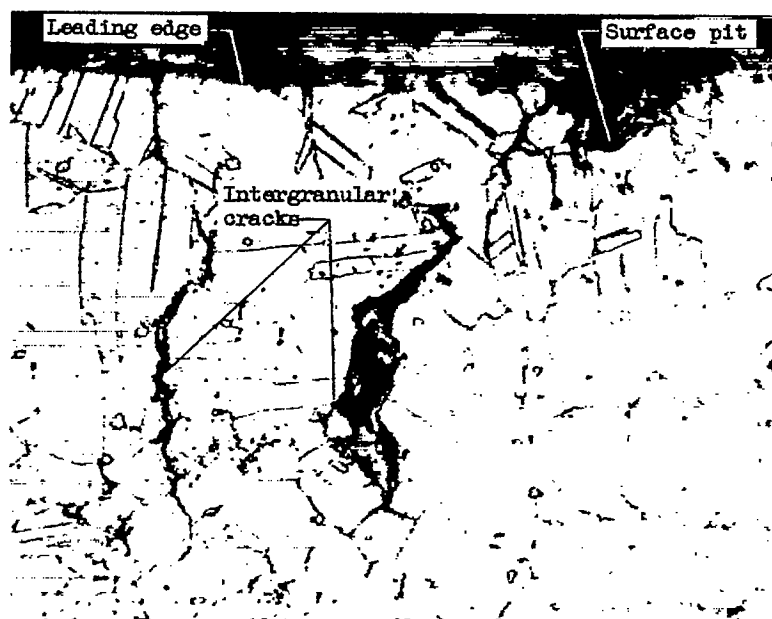
Figure 9. - Initial crack penetration in AISI 321 stainless steel after 319 cycles (106 hr, 20 min) of operation. X500.
